Anderson Home Inspection

Doc #: Sample Home Inspection Report Inspector: Donn Anderson

Date: 5/3/2011

Dwelling Address: 1234 Main St
Your Town, WI

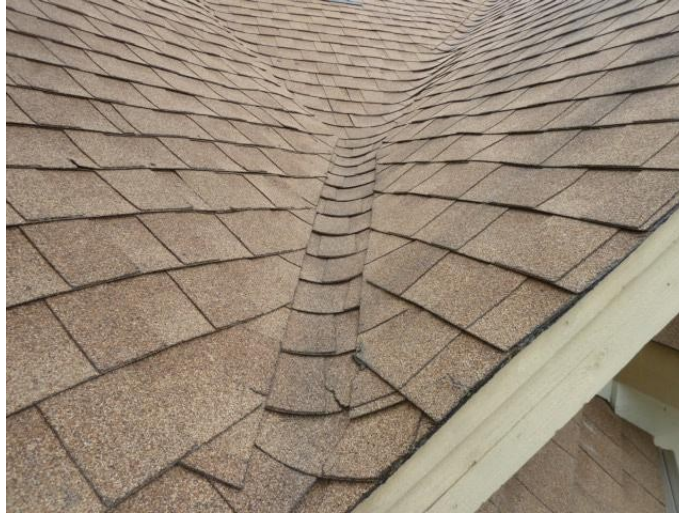
**Flashings & Roof
Penetrations**

Woven valleys. Siding proximity inhibits visual assessment of flashing condition at roof/sidewall junction. (1.2.3). Sidewall flashings at dormers deteriorate over time and require attention. Check all roof flashings as part of your normal maintenance routine to prevent water infiltration. Be sure to evaluate step flashing condition when new roof covering is installed.

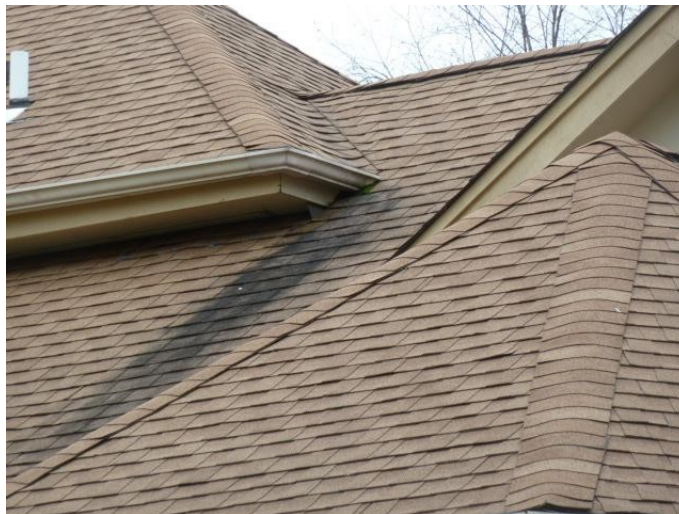
Algae were observed on the shingles. Clean as needed to preserve the life of the roof covering.

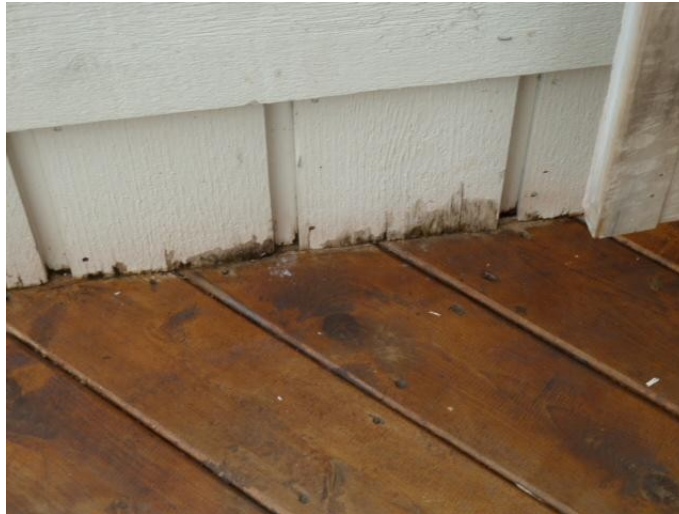
Siding/ Cladding

Worn paint/ finish. Maintain as needed to retard accelerated deterioration.

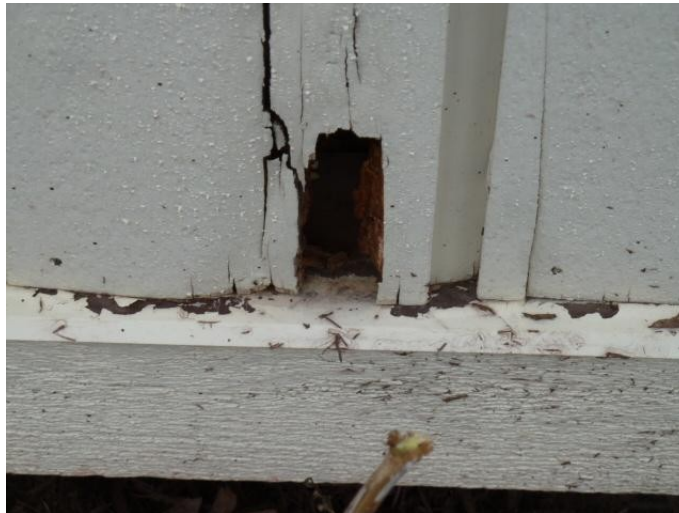
Damaged siding in one or more areas. Repair, replace or address all damaged siding as needed.

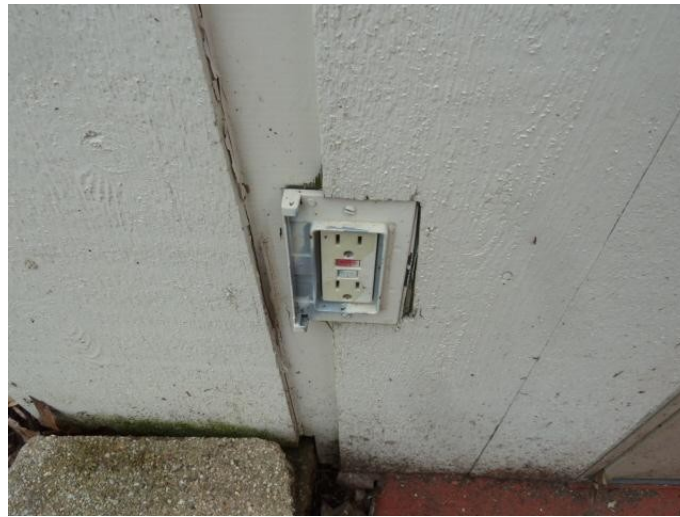
Missing proper cover. Repair, replace or address as needed.

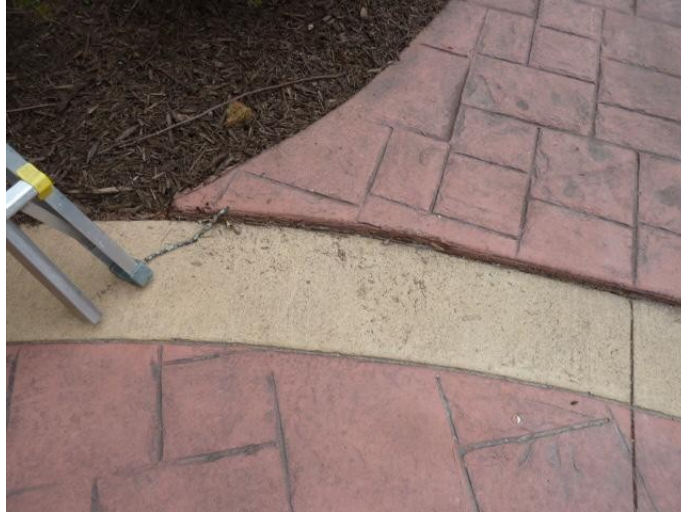
Walks

Settling. Adjacent sections of walkways are more than 1/2" difference in height. Correct or address this trip hazard as needed for safety.

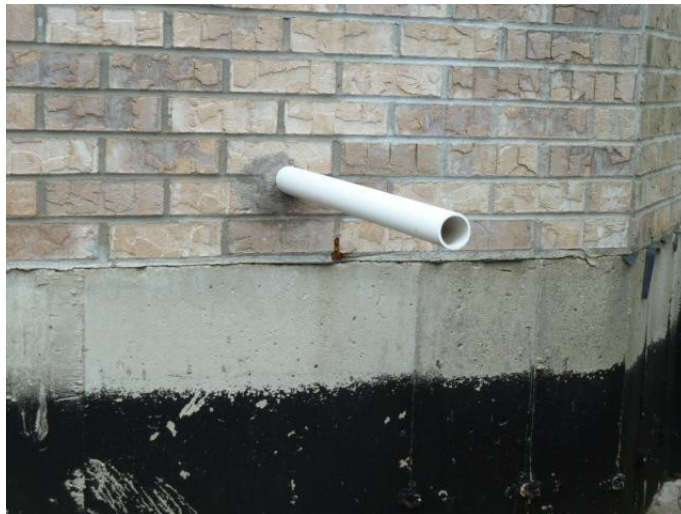
Sump pump discharge

Extend the discharge line at least 10' - 15' away from the foundation wall.

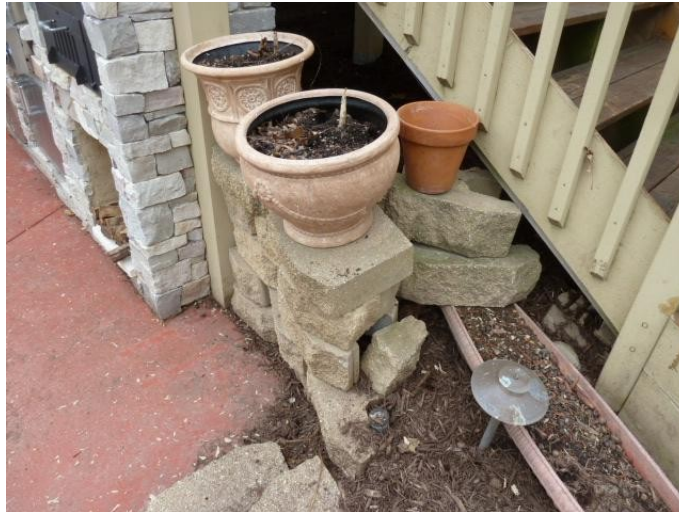
Displaced retaining wall at back planters should be corrected prior to becoming unstable or unsafe.

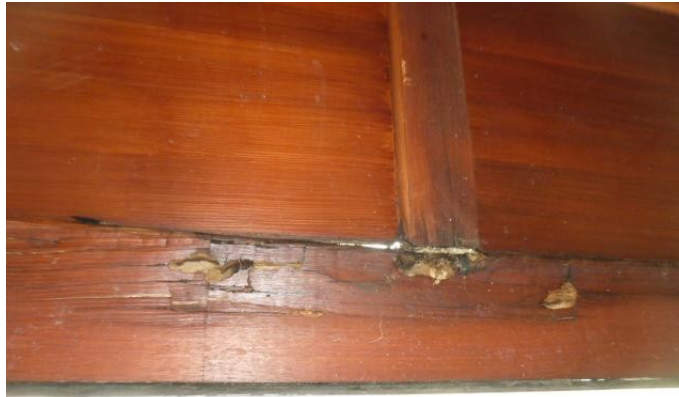
Vehicle Door/s 3 doors. Wood. Overhead.

Worn paint/ finish. Some rotted sections of OH door/s. Maintain as needed to retard accelerated deterioration. Repair, replace, or address as needed.

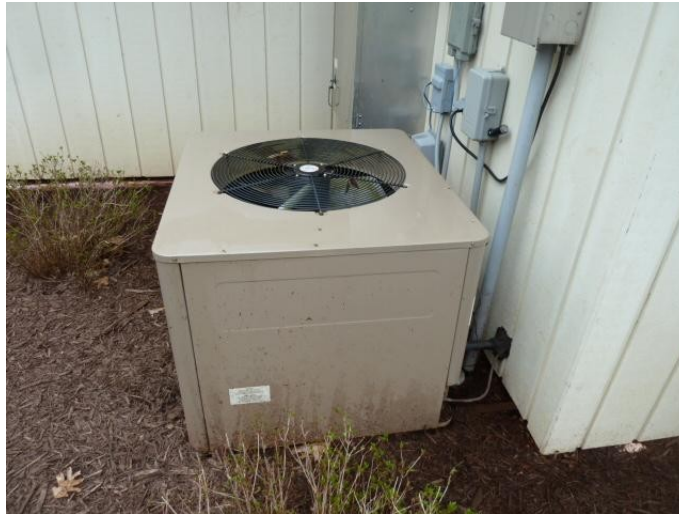
Leveling condenser unit is required to improve efficiency, operation, and prevent possible damage. (4.2.3)

Maintenance recommended.

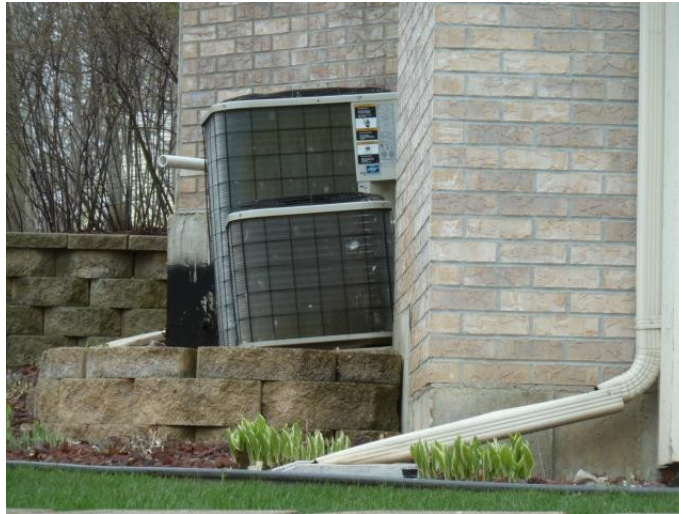
Leveling condenser units is required to improve efficiency, operation, and prevent possible damage. (4.2.3)

Maintenance recommended.

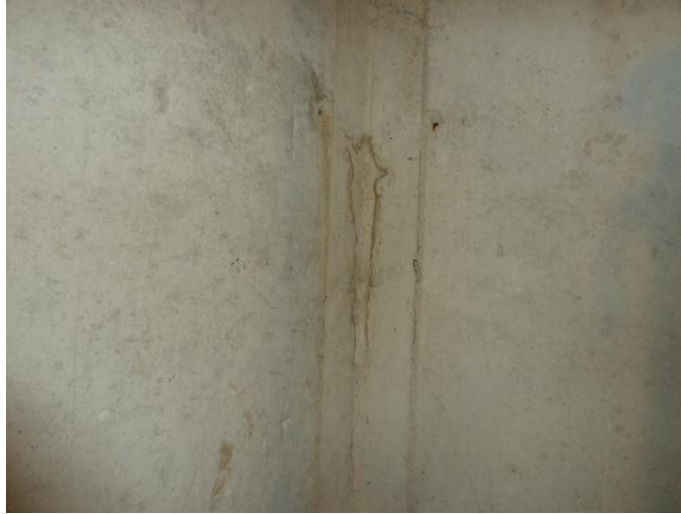
Wall Cracks/
Displacement

Shrinkage cracks noted in corners. Signs off minor seepage. Address as needed.

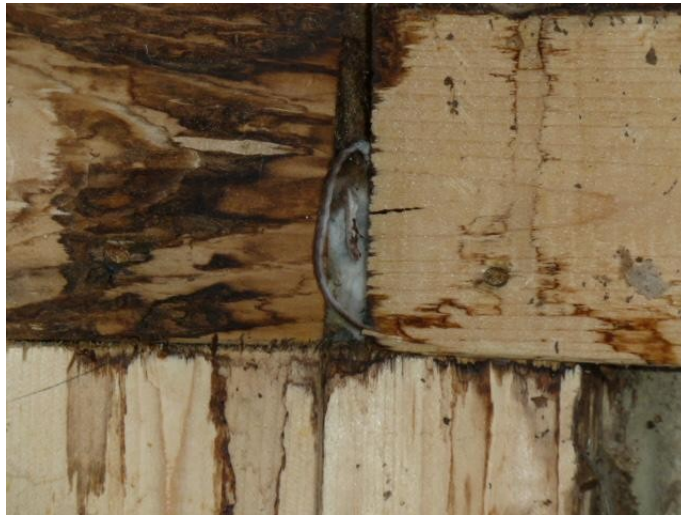
Moisture/ Seepage

At wall near sump crock. Mice and water entry. For health reasons, we recommend further evaluation by a Qualified Specialist.

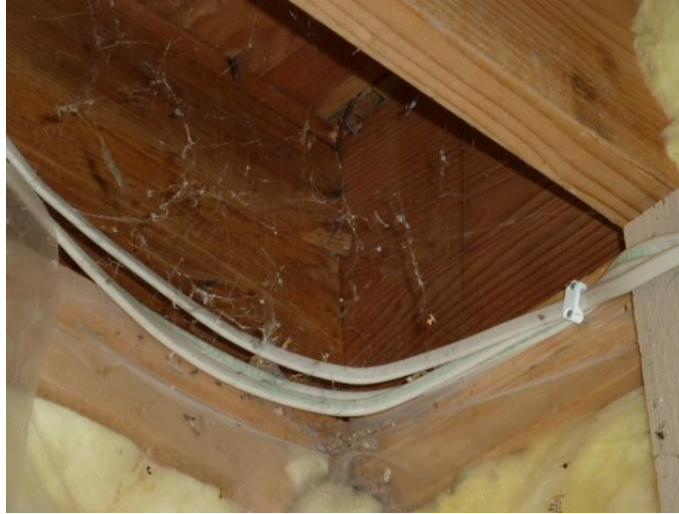
Box Sill Insulation Fiberglass. Expandable Foam.

Some missing insulation. Install as needed.

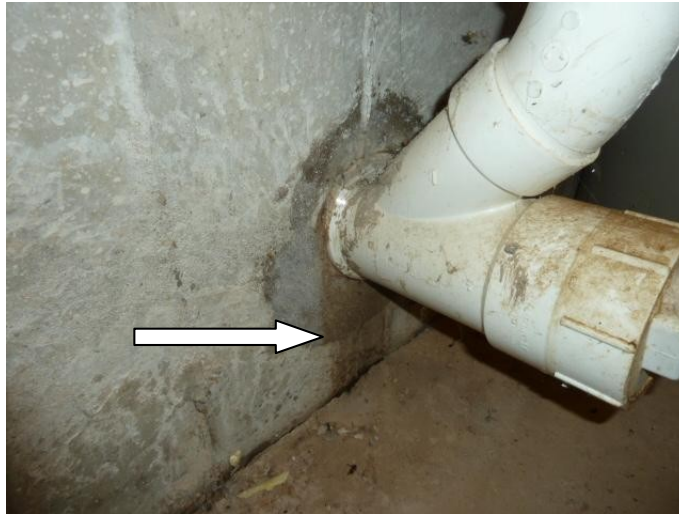
Drain/ Waste/ Vent PVC.

Leaking/ staining noted at wall/ stack. Address this condition as needed for health reasons.

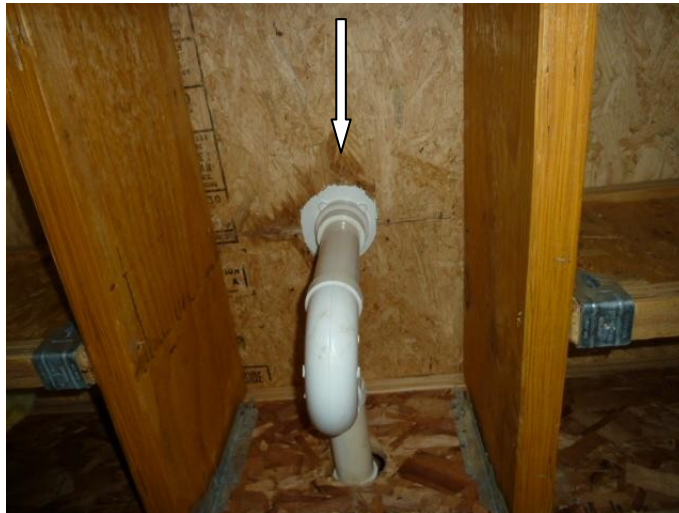
Leaks or Corrosion

Staining at subfloor under Master bathroom indicates past or ongoing leaking. Contact a qualified specialist for further evaluation to determine the course of remedial action.

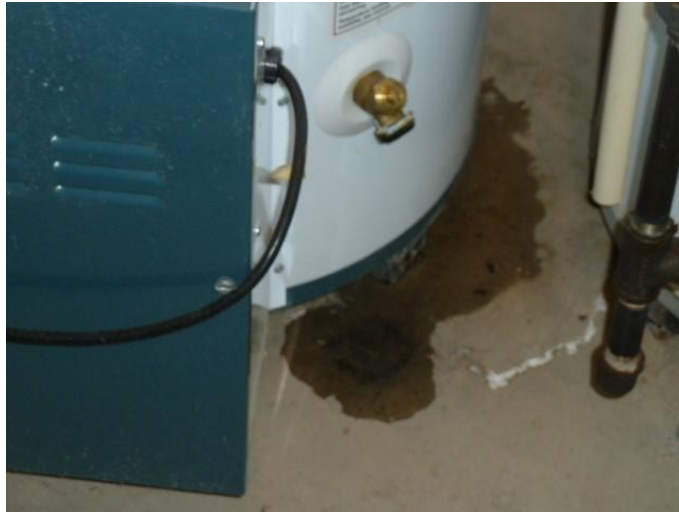
Leak at isolation or drain valve. Repair or replacement is recommended.

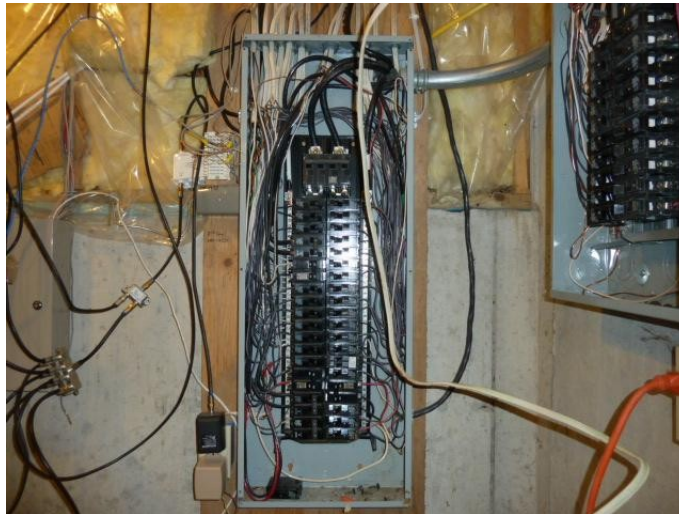
Special Attention

Orphan wires in front of auxiliary panels. Confirmation of the location of this dead circuit is beyond the scope of this inspection. Correction of this safety concern is recommended.

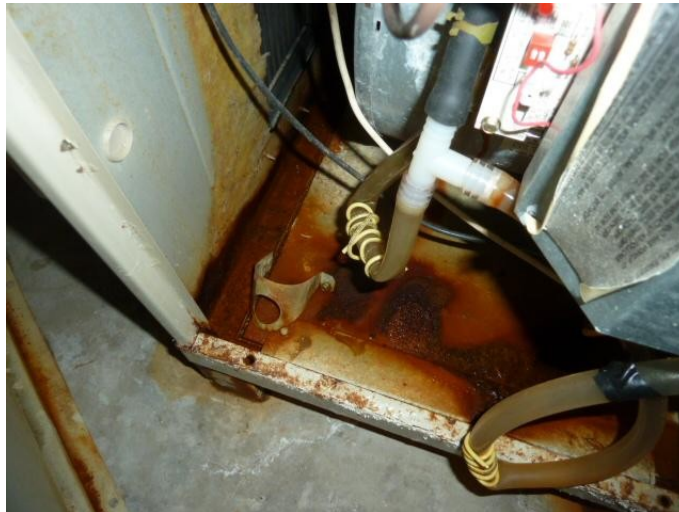
Corrosion in vestibule. We recommend a Service and Safety check be performed on the heating system by a qualified specialist prior to the end of your inspection contingency. A qualified specialist may find other concerns beyond the scope of this inspection.

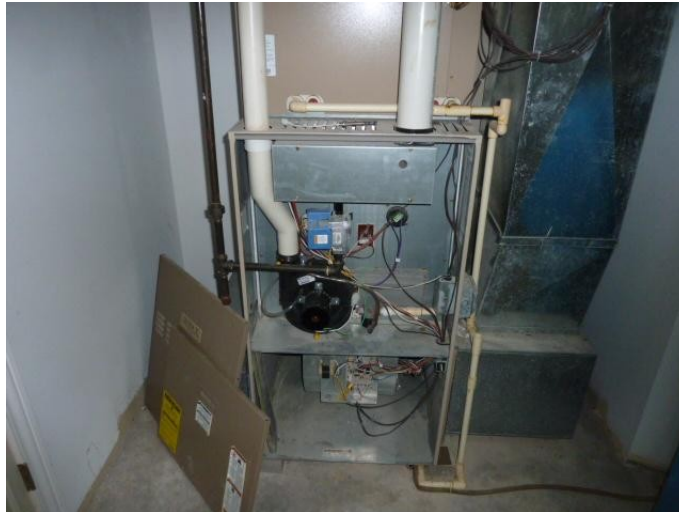
Signs of deferred maintenance. Contact a licensed heating contractor for a service and safety check to include combustion safety testing and evaluation of the heat exchanger for damage prior to the end of your inspection contingency. A heating contractor may find other conditions not found within the scope of this inspection that may be significant.

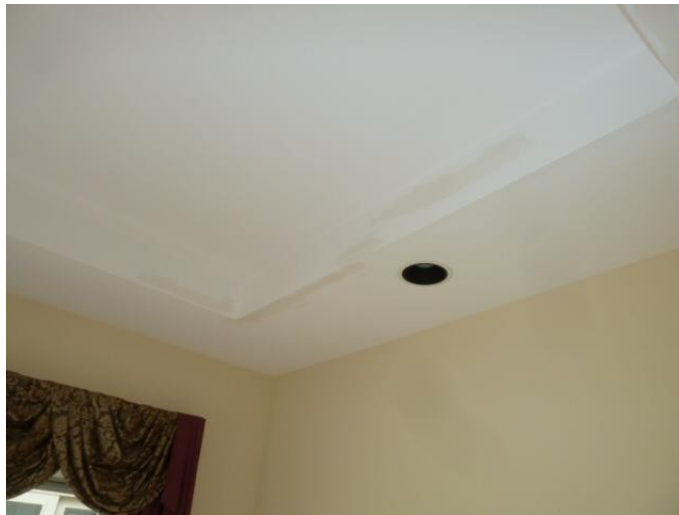
Ceiling Cracks/
Stains

Patched ceiling in alcove to deck at master bedroom. Determine source and address as needed.

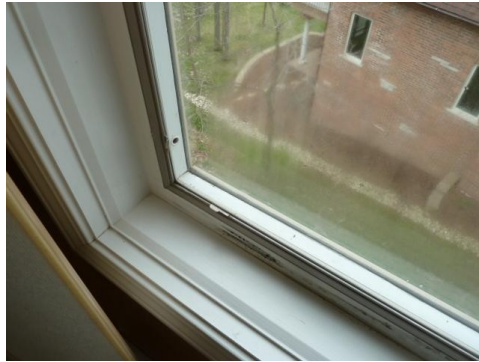
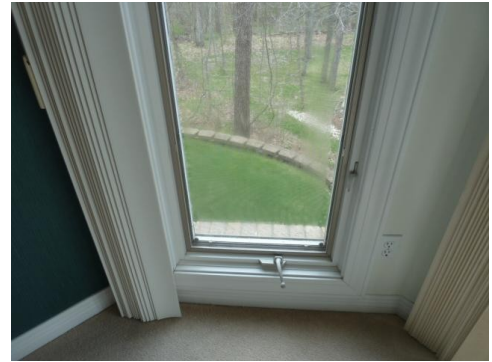
Glazing Double Pane.

There is condensation between the panes of glass in one or more locations (SE2 Bedroom, SE1 Bedroom). Confirm the condition of all window seals prior to the end of your home inspection contingency. Glass replacement is typically required to address this condition.

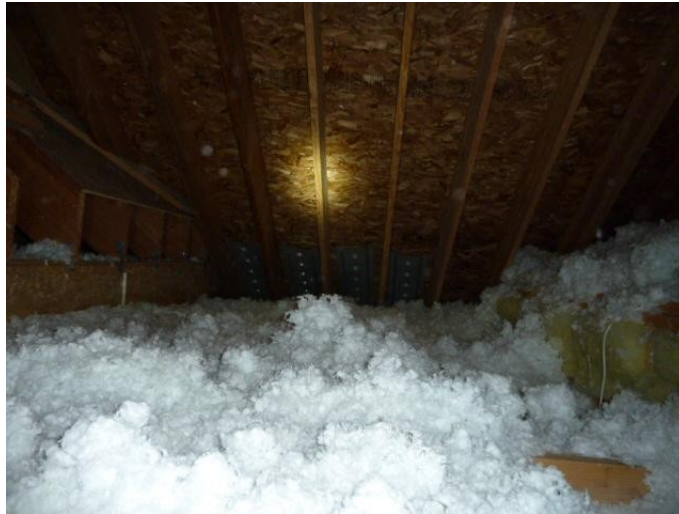
Insulation Blown/loose. Fiberglass. Redistribute or add insulation to eliminate voids in areas of inadequate insulation.

The "average" amount of insulation in the attic is approximately R-30". Today's minimum requirement is R-38. Comm 22.32 (1)
