Property Inspection Report

1234 Main St
Milwaukee, WI 53211

Inspection Date: 11/21/17

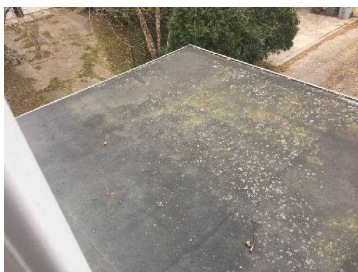
Material/s: Dimensional shingles, Rubber - **Algae noted on rubber roof**

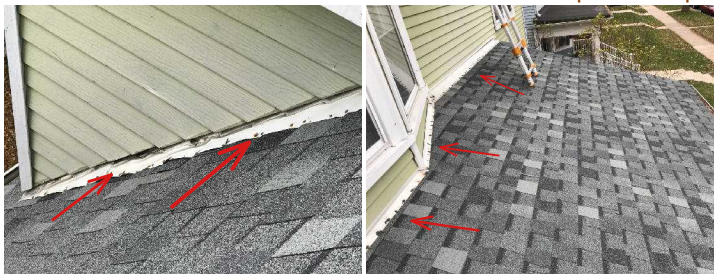
4. Unremarkable Sags/ Crowns: No noteworthy roof sag was observed at the time of the inspection
5. Marginal/ Maintenance Flashing: Metal - **Not replaced at sidewalls at last re-roof. There is an above average risk of leaking on flashing more than 20 years old. Confirm leak history with owner. If history is unavailable or unsubstantiated, contact a qualified professional for further evaluation**

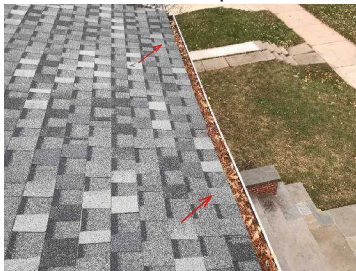
6. Unremarkable Valley/s: Preformed metal
7. Unremarkable Plumbing Vent/s: Metal with metal flashing
8. Unremarkable Electrical Service: Mast
9. Marginal/ Maintenance Gutters & Downspouts: Metal - **Cleaning advised**

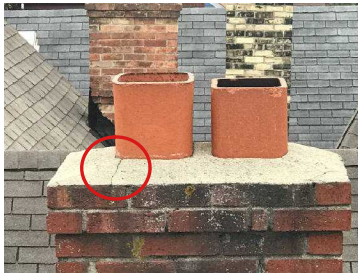
14. Marginal/ Maintenance Flue/ Crown (cap): Clay flue tile/ Mortar crown - Observing the interior of the flue is beyond the scope of this inspection. Though possibly acceptable at the time of construction we advise upgrading the crown (cap) in compliance with current regulatory requirements. SPS 321.30 Masonry chimneys - Chimney caps. Chimneys shall be provided with pre-cast or cast in place concrete chimney caps. Chimney caps shall have a minimum thickness of 2 inches, shall slope outwards away from the flue, and shall provide a one-inch overhang and drip edge on all sides. A slip joint shall be installed between the flue and the cap. The slip joint shall be filled with 1/4" inch felt or similar material and shall be caulked with high-temperature caulk or similar material to prevent water infiltration - **Crown is cracked. Repair or replace as appropriate**

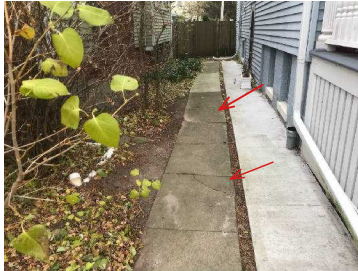
3. Safety or Health Concern Walks: Concrete, Stone pavers - Cracks and 1/2" or more difference in height between adjacent sections of walkway. Correct or address this and all similar trip hazards as appropriate for safety

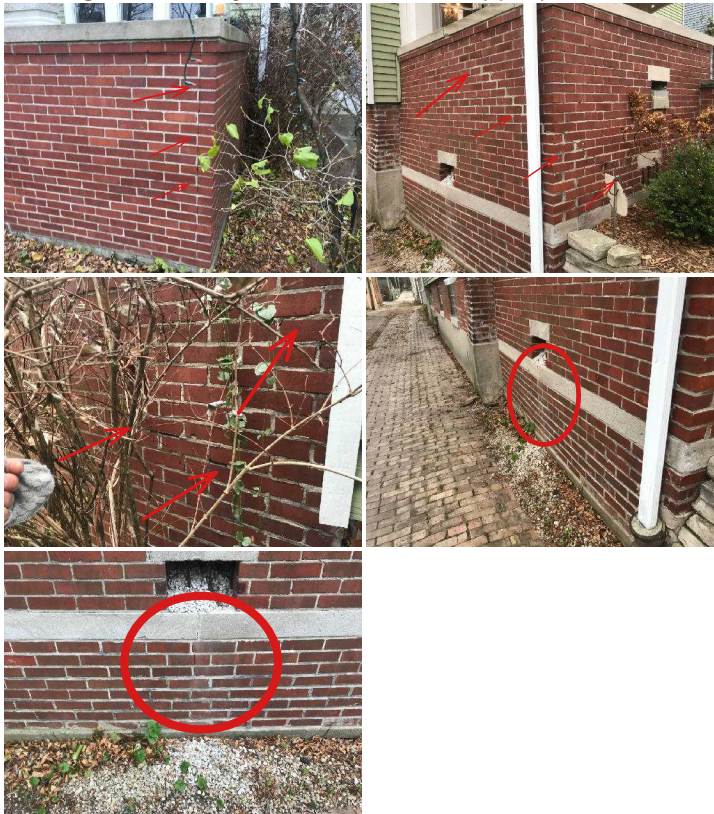
Wall movement: No racking observed
Steps: Concrete, Pavers
Stoops: Concrete
Porch: Masonry - Settling of the porch was noted.

Cracking appears significant.

Bowing of masonry wall. Address as appropriate for safety reasons

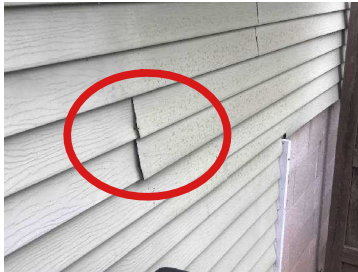
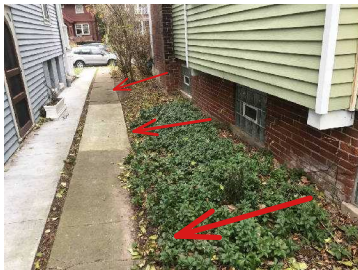
| 12. Marginal/ Maintenance | Siding/ Cladding: Metal - Loose in some areas |
| 15. Marginal/ Maintenance | Drainage/ Grading: ! Adjust and maintain soils to slope away from the foundation at all sides of the home to provide a minimum drop of 1/2" - 1" for every foot away from the foundation to a point 10' away from the foundation or to the lot line, whichever is less (SPS 321.12) to help minimize the risk of seepage and other water related foundation problems. Adjust hard surfaces such as driveways, concrete walks, asphalt, etc. at all sides of the structure to provide a minimum drop of 1/4" - 1" for every foot away from the foundation |

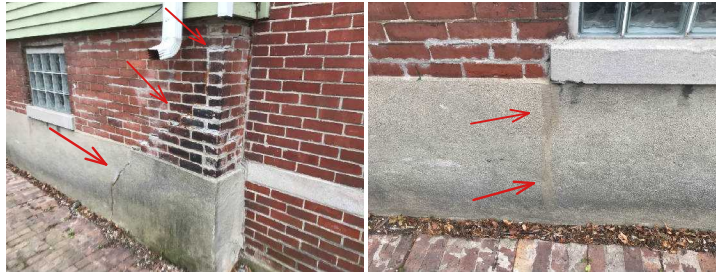
16. Repair Estimate Exposed foundation: Brick - Corner cracks. This indicates wall movement. Check for foundation wall movement and repair as appropriate. Anticipate leaks and seepage until cracks are properly addressed.

Cracks. All cracks have a potential for allowing water infiltration. Improvement of this condition is advised. Anticipate leaks until this condition is properly addressed

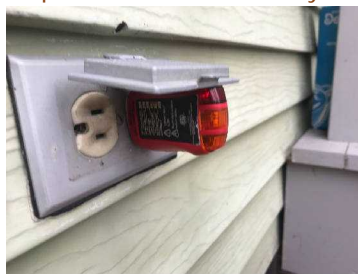
17. Unremarkable Basement windows: Glass block
18. Unremarkable Window Wells: n/r
19. Unremarkable Hose Bibs: Operable valve; no water. Water turned off at another location?
20. Safety or Health Concern Electric: Grounded outlets - Improper wiring, Reversed polarity noted. Correcting this safety concern is required.

Though upgrading may not be mandatory, GFCIs have been required for many years on exterior outlets. We advise upgrading all homes to comply with current regulatory requirements as a safety improvement

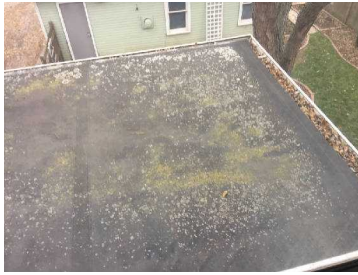
23. Marginal/ Maintenance Caulking: Attention advised - Caulking maintenance is currently required to help prevent water infiltration. Check all doors, windows, siding trim joints and mechanical penetrations and caulk as appropriate
24. Unremarkable Patio: Pavers
25. Safety or Health Concern Balcony: Rubber deck covering - Guardrail missing. Add 36" high (min) guardrail to deck for safety

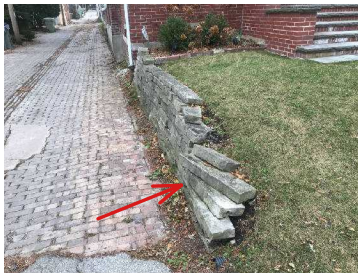
26. Marginal/ Maintenance Retaining Walls: Stone - Displaced, Appropriate corrective action advised for safety reasons

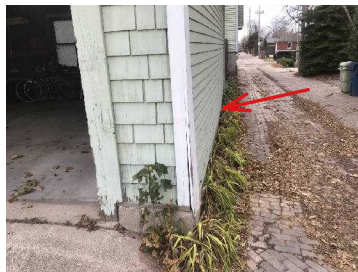
1. Type of Structure: Detached # of Vehicle Doors: 2
2. Unremarkable Driveway/ Slab: Unremarkable
3. Marginal/ Maintenance Garage Walls: Limitations - wall covering and stored personal belongings - **Bumped out sidewall.**

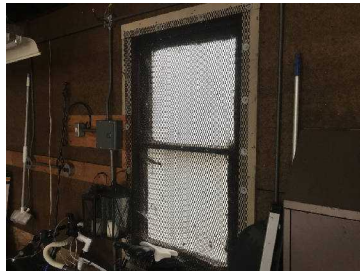
11. Unremarkable Steps: Concrete
12. Unremarkable Roof Covering: Asphalt shingle
13. Repair Estimate Gutters & Downspouts: None - None - add. Gutters and downspouts are required per most municipalities. We advise proper installation and maintenance to help minimize risk of foundation problems. You should have at least one downspout for every 600 to 800 square feet of roof surface
14. Unremarkable Roof Structure: Conventional framing
15. Unremarkable Service Doors: Metal
16. Marginal/ Maintenance Windows: INACCESSIBLE - Some of the windows in the home were inaccessible at the time of the inspection. Furnishings and or personal belongings blocked the inspector's access from operating some of the windows or determining the condition of the glass/ glazing - Worn finish on window/s.

Windows have steel grating, not allowing access to check for condition and movement. Check all window/s for wear and operation prior to the end of your inspection contingency. Maintain, repair or replace as needed

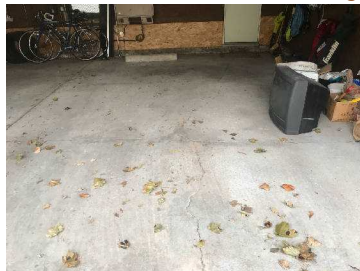
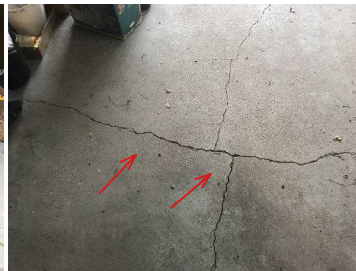
17. Unremarkable Ceiling: Exposed framing
18. Marginal/ Maintenance Floor/Foundation: Slab on grade - concrete - Cracks in slab exceeding 1/4 inch should be filled with an appropriate material to help avoid continued damage from freeze/ thaw conditions

Some corner block cracking

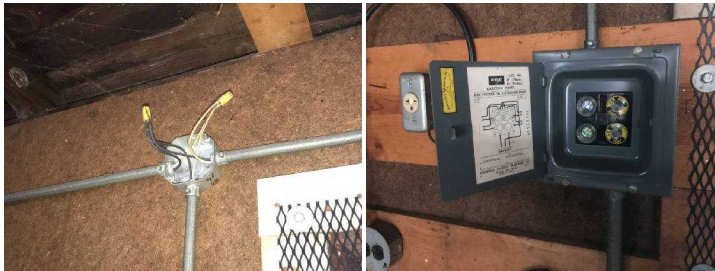
Cover plate/s damaged or missing. Replace all damaged or missing box covers as required for safety, Exposed wiring noted. Correction of this condition is required for safety.

Non compliant federal pacific junction box with fuses. This may have been compliant when installed. Contact a licensed electrician for appropriate corrective action

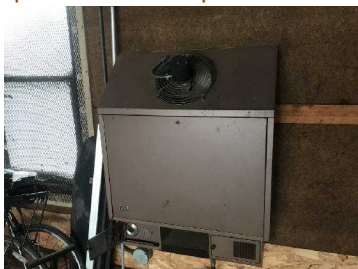
Do not operate system for safety reasons until serviced and approved for use by a qualified HVAC professional

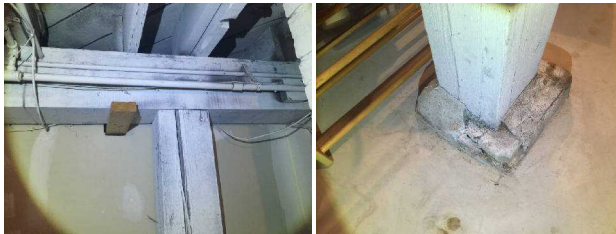
Beams & Columns: Wood/ Wood - Checking/ cracking. Wood beams and columns shrink and crack when drying. The amount of checking is not abnormal at this time. Consider re-evaluating in 5 years.

Concrete plinths at base of columns are spalling. Immediate attention not required. Evaluate furthering if spalling continues.

If unevenness of floors above is bothersome to you contact a qualified specialist for remedial cost estimate. Note: Addressing uneven floor will likely include modification to foundation columns.

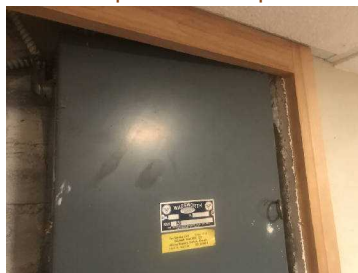
Special Attention Electrical: ! Accessibility of panel. Clearance to be able to remove panel is inadequate. Trim prevents removal.

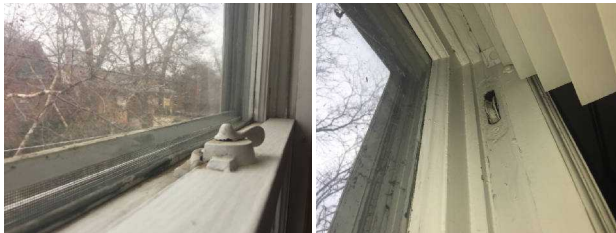
9. Marginal/ Maintenance Window/s: Wood sash - *Missligned sashes, missing sash cords. Adjust/ address a appropriate*

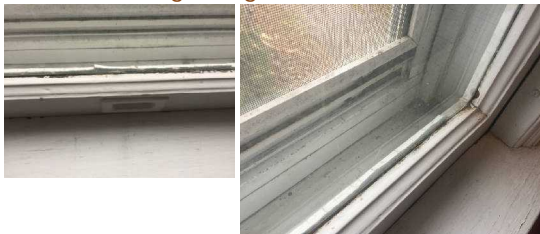
10. Marginal/ Maintenance Glazing: Single pane and Insulated glass panel/s - *Reglaze. Some glazing is in poor condition. Reglazing is advised to decrease heat loss*

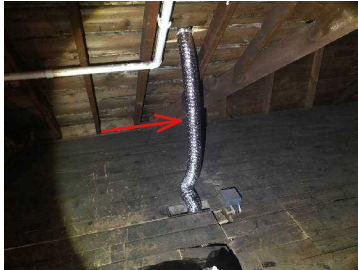
| 9. Marginal/ Maintenance | Exhaust Fan Venting: Through the roof. Exhaust/s vent properly through the roof into the atmosphere - Uninsulated vent/s. We advise insulating vents to minimize risk of dew point/ condensation damage to building components |

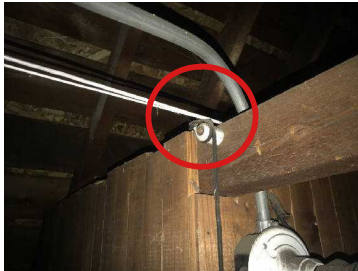
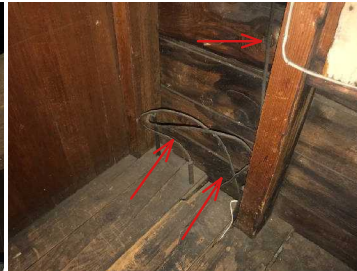
Dead "knob & tube" wiring in some areas. Not all knob & tube was tested. We advise further evaluation by a qualified electrician for safety

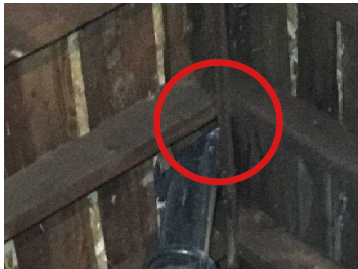
13. Marginal/ Maintenance Plumbing Soil Stack: Iron, PVC - Light leak at plumbing stack. Repair/ replace stack flashing to minimize risk of water entry

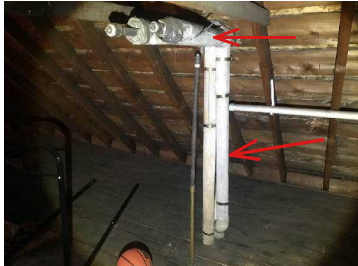
14. Questionable Special Attention Attic: ! Asbestos wrapped pipes? Confirm and remediate condition if applicable.

Railing missing on stairwell.

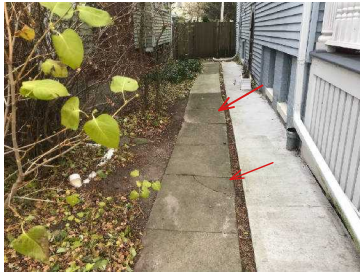
1. The Exterior Surface Walks: Concrete, Stone pavers - Cracks and 1/2" or more difference in height between adjacent sections of walkway. Correct or address this and all similar trip hazards as appropriate for safety

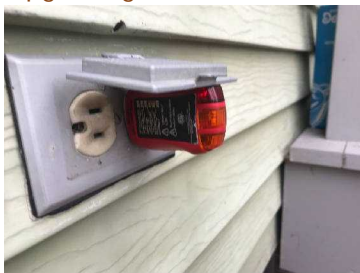
2. The Exterior Surface Electric: Grounded outlets - Improper wiring, Reversed polarity noted. Correcting this safety concern is required.

Though upgrading may not be mandatory, GFCIs have been required for many years on exterior outlets. We advise upgrading all homes to comply with current regulatory requirements as a safety improvement

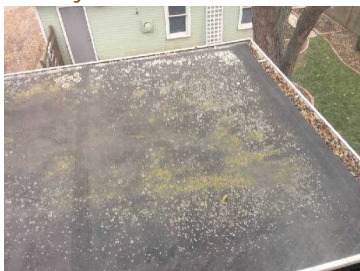
3. The Exterior Surface Balcony: Rubber deck covering - Guardrail missing. Add 36" high (min) guardrail to deck for safety

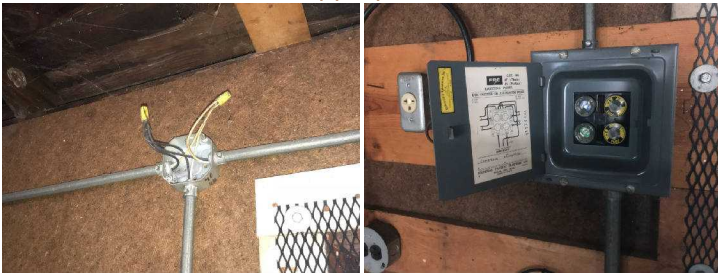
Non compliant federal pacific junction box with fuses. This may have been compliant when installed. Contact a licensed electrician for appropriate corrective action

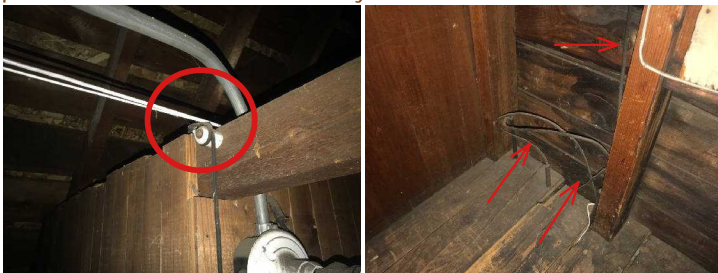
Dead "knob & tube" wiring in some areas. Not all knob & tube was tested. We advise further evaluation by a qualified electrician for safety

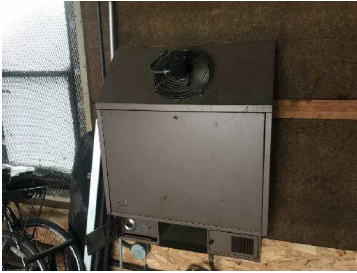
Do not operate system for safety reasons until serviced and approved for use by a qualified HVAC professional

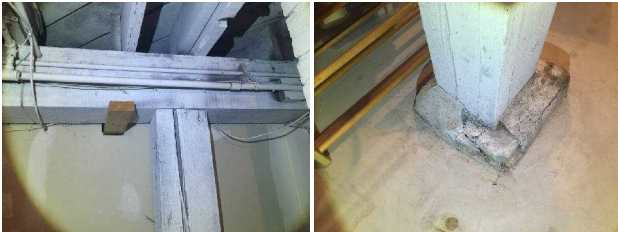
If unevenness of floors above is bothersome to you contact a qualified specialist for remedial cost estimate. Note: Addressing uneven floor will likely include modification to foundation columns.

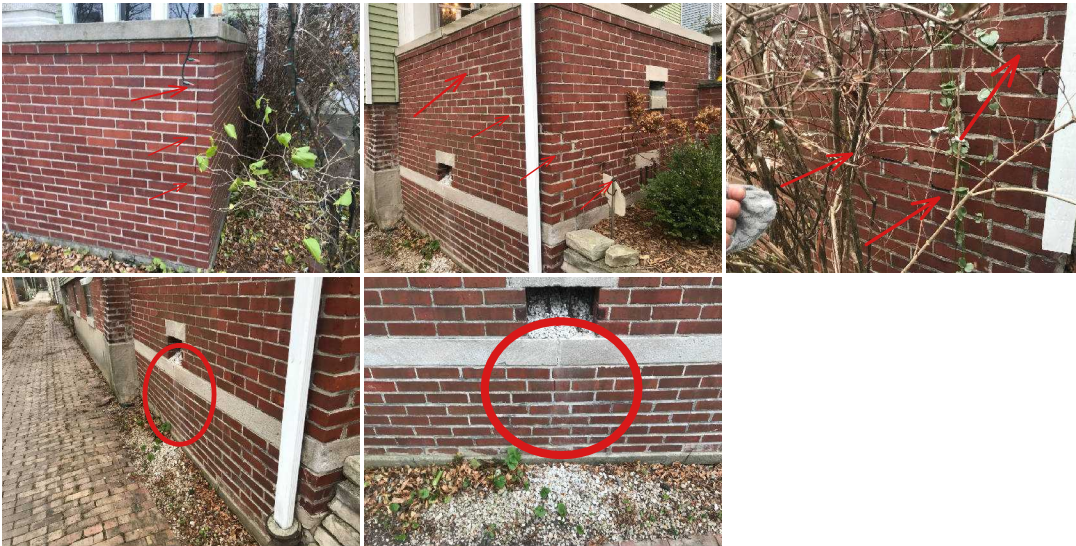
Bowing of masonry wall. Address as appropriate for safety reasons

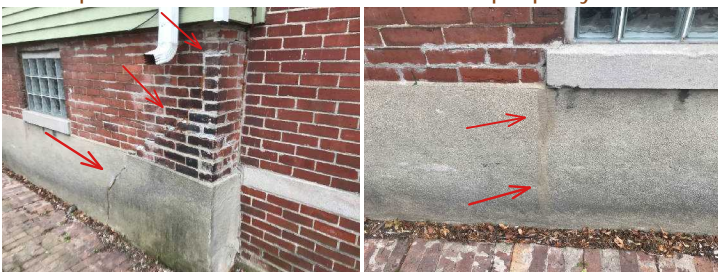
2. The Exterior Surface Exposed foundation: Brick - Corner cracks. This indicates wall movement. Check for foundation wall movement and repair as appropriate. Anticipate leaks and seepage until cracks are properly addressed.

Cracks. All cracks have a potential for allowing water infiltration. Improvement of this condition is advised. Anticipate leaks until this condition is properly addressed

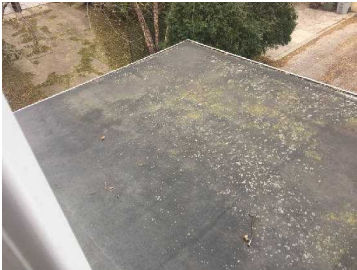
1. The Roof Surface Material/s: Dimensional shingles, Rubber - **Algae noted on rubber roof**

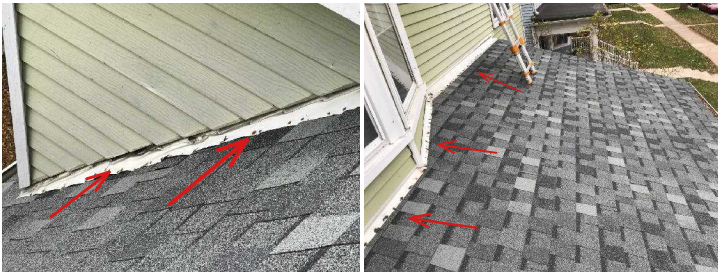
2. The Roof Surface Flashing: Metal - **Not replaced at sidewalls at last re-roof. There is an above average risk of leaking on flashing more than 20 years old. Confirm leak history with owner. If history is unavailable or unsubstantiated, contact a qualified professional for further evaluation**

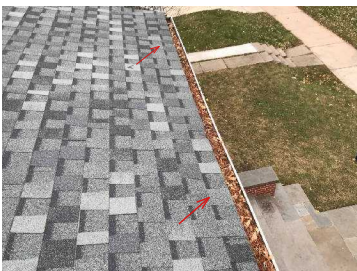
3. The Roof Surface Gutters & Downspouts: Metal - **Cleaning advised**

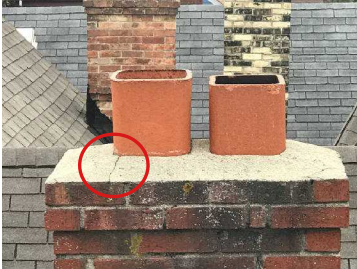
4. Side of house Chimney Flue/ Crown (cap): Clay flue tile/ Mortar crown - Observing the interior of the flue is beyond the scope of this inspection. Though possibly acceptable at the time of construction we advise upgrading the crown (cap) in compliance with current regulatory requirements. SPS 321.30 Masonry chimneys - Chimney caps. Chimneys shall be provided with pre-cast or cast in place concrete chimney caps. Chimney caps shall have a minimum thickness of 2 inches, shall slope outwards away from the flue, and shall provide a one-inch overhang and drip edge on all sides. A slip joint shall be installed between the flue and the cap. The slip joint shall be filled with 1/4" inch felt or similar material and shall be caulked with high-temperature caulk or similar material to

prevent water infiltration - Crown is cracked. Repair or replace as appropriate

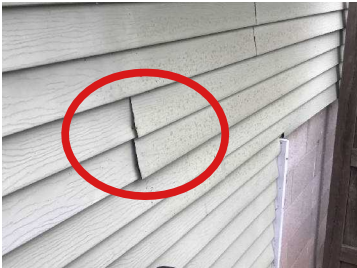
5. The Exterior Surface Vegetation: Attention advised - Tree/s - close enough to the structure to pose a risk of foundation and or drain tile damage. Live tree roots often mirror the canopy of the tree and may infiltrate the drain tiles and or put pressure on the foundation and foundation wall/s. Dead trees will often fall unexpectedly onto property causing damage or harm. Contact a qualified specialist to discuss maintenance options
6. The Exterior Surface Siding/ Cladding: Metal - Loose in some areas

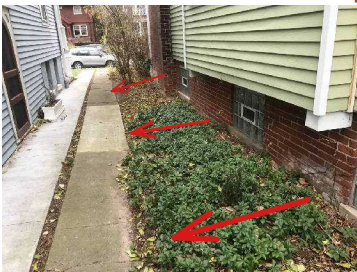
7. The Exterior Surface Drainage/ Grading: ! Adjust and maintain soils to slope away from the foundation at all sides of the home to provide a minimum drop of 1/2" - 1" for every foot away from the foundation to a point 10' away from the foundation or to the lot line, whichever is less (SPS 321.12) to help minimize the risk of seepage and other water related foundation problems. Adjust hard surfaces such as driveways, concrete walks, asphalt, etc. at all sides of the structure to provide a minimum drop of 1/4" - 1" for every foot away from the foundation

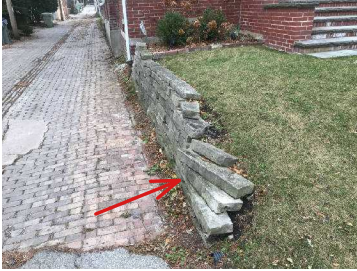
9. The Exterior Surface Retaining Walls: Stone - Displaced, Appropriate corrective action advised for safety reasons

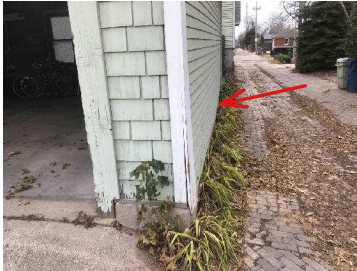
10. The Garage Garage Walls: Limitations - wall covering and stored personal belongings - Bumped out sidewall.

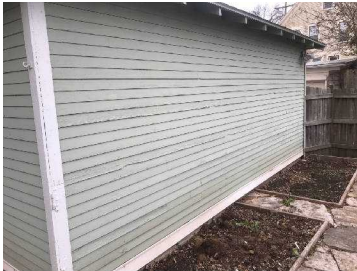
11. The Garage Siding: Metal - Worn finish

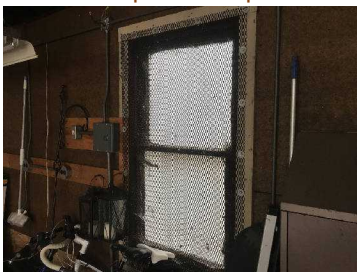
12. The Garage Windows: INACCESSIBLE - Some of the windows in the home were inaccessible at the time of the inspection. Furnishings and or personal belongings blocked the inspector's access from operating some of the windows or determining the condition of the glass/ glazing - Worn finish on window/s.

Windows have steel grating, not allowing access to check for condition and movement. Check all window/s for wear and operation prior to the end of your inspection contingency. Maintain, repair or replace as needed

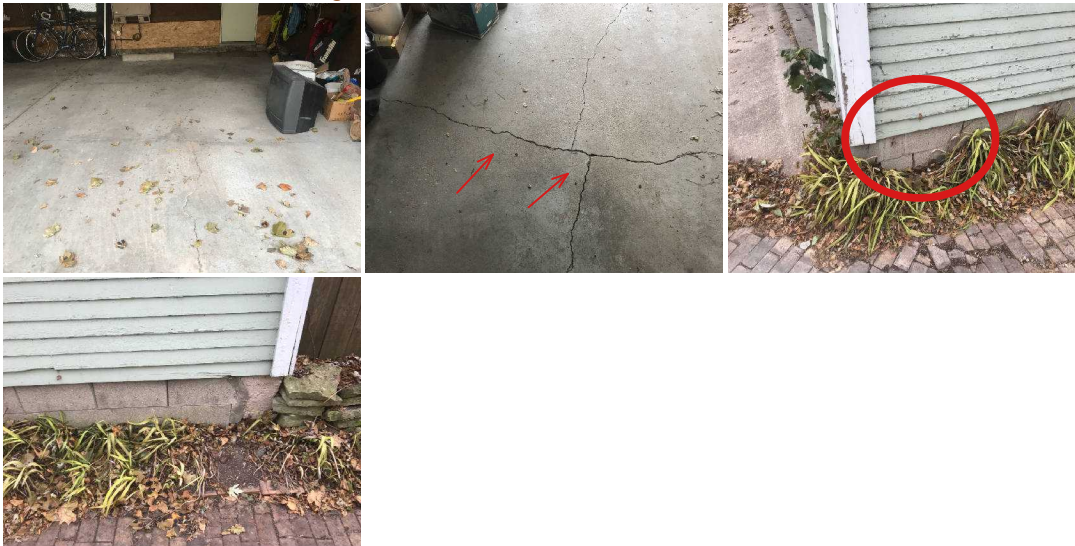
Some corner block cracking

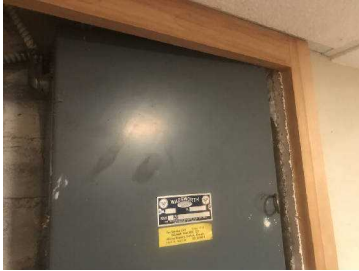
17. Basement Electric Panel Special Attention Electrical: ! Accessibility of panel. Clearance to be able to remove panel is inadequate. Trim prevents removal.

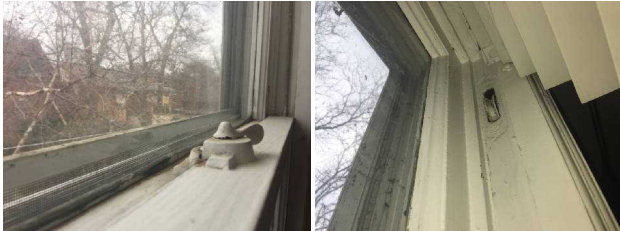
19. The Living Space Window/s: Wood sash - Missligned sashes, missing sash cords. Adjust/ address a appropriate

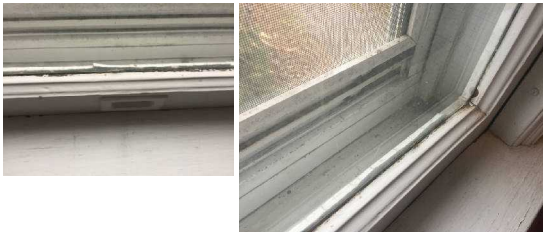
20. The Living Space Glazing: Single pane and Insulated glass panel/s - Reglaze. Some glazing is in poor condition. Reglazing is advised to decrease heat loss

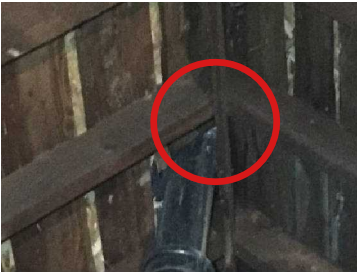
22. The Attic Plumbing Soil Stack: Iron, PVC - Light leak at plumbing stack. Repair/ replace stack flashing to minimize risk of water entry

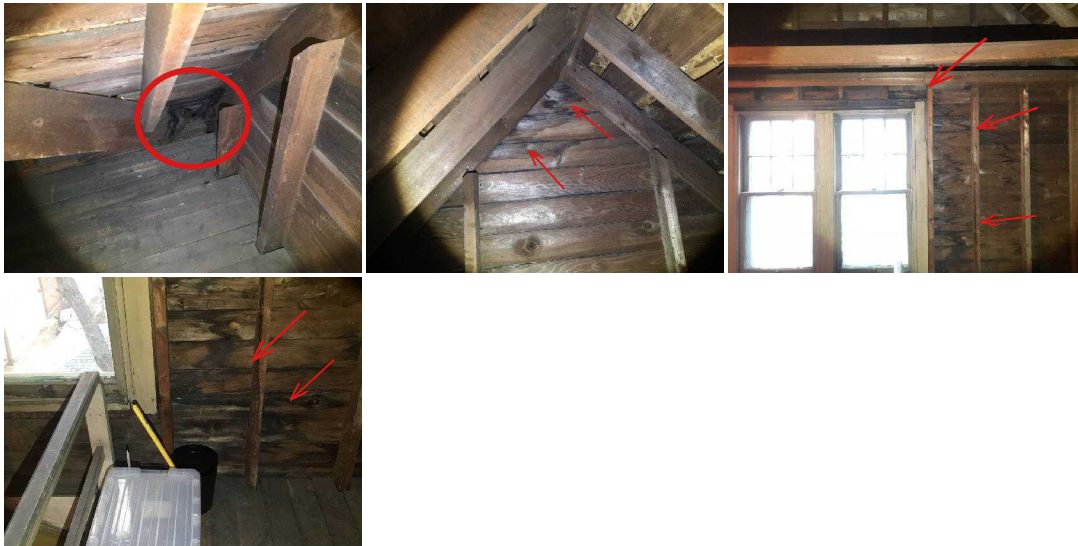
1. The Attic Signs of Leaks/ Moisture: ! Moisture stains indicate past or ongoing leaks. Confirm history with seller. If history is unavailable or unsubstantiated, contact a qualified specialist for further evaluation and approval or a remedial cost estimate
