Property Inspection Report

1234 Main St
Milwaukee, WI 53211

Inspection Date: 11/21/17

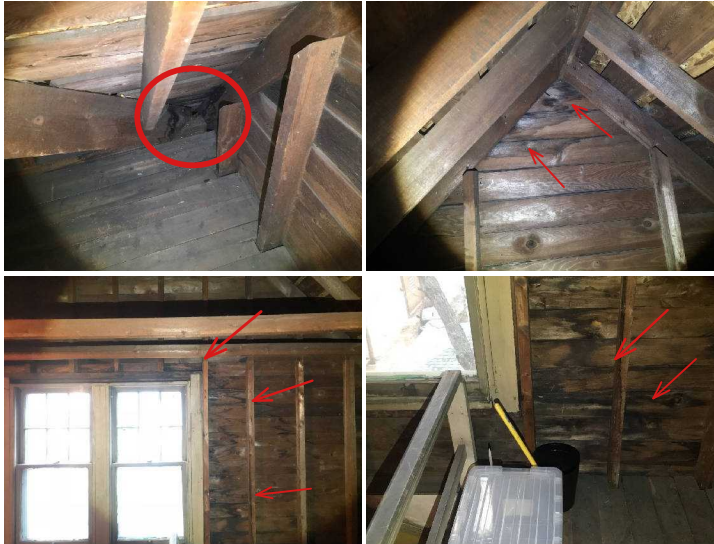
13. Marginal/ Maintenance Plumbing Soil Stack: Iron, PVC - Light leak at plumbing stack. Repair/ replace stack flashing to minimize risk of water entry

22. The Attic Plumbing Soil Stack: Iron, PVC - Light leak at plumbing stack. Repair/ replace stack flashing to minimize risk of water entry
